2021 CLG Grant Application

**Vermont Certified Local Government Program
2021 Grant Application Form**

Name of CLG Community: Bennington, VT

Bennington College Historic Preservation Plan

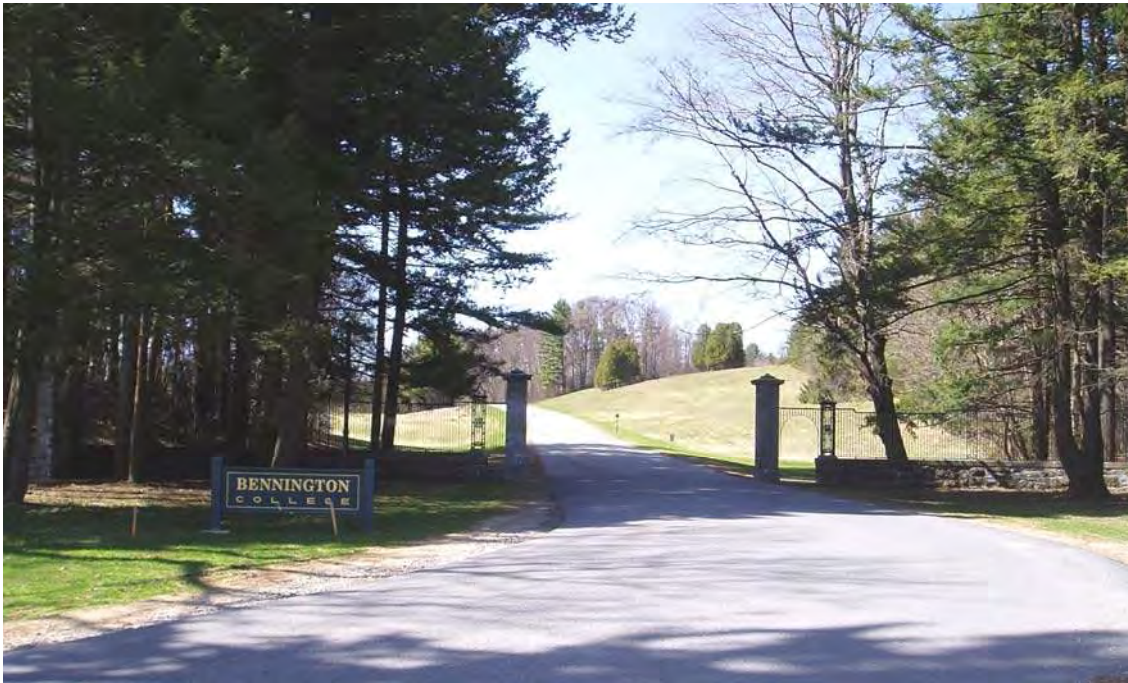
Detail of the limestone post and arched opening for the walking path.

- 1) Future mortar repairs should match the historic mortar color, texture, strength and profile, with special attention paid to the original character of the convex or beaded mortar joints typically found in turn of the 20th century masonry foundations and buildings.
- 2) Replace the missing ball finials matching the historic size and profiles based on the archival photo, and use masonry to match the existing capstone on the posts.
- 3) Plant native canopy trees along the drive as recommended in the Bennington College Landscape Master Plan (2004).

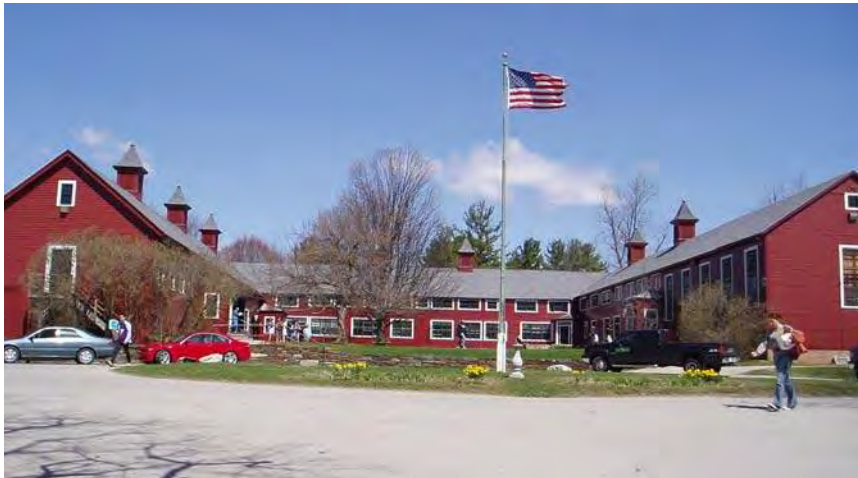
Current view looking north toward west and east wings and center connector.

- 1) Windows: Continue to retain and repair as necessary the existing steel casement windows. When new interior storms are needed carefully install new storms to assure a weather tight fit. Any new windows that might be needed should match the historic window dimensions, window pane configuration and muntin profiles (snap-in muntins are not appropriate for historic buildings).
- 2) Some modifications to the interior floorplan to accommodate changes in office and educational needs are appropriate and will not affect the architectural integrity of the building.

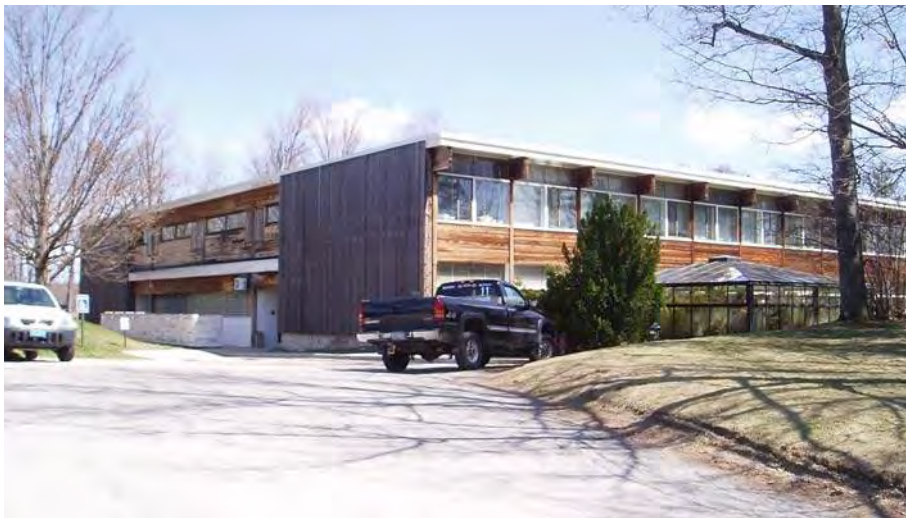
View looking northeast of front and west elevations.

- 1) Aluminum frame, double-glazed, clear low-e glass for the large windows and sliding doors is an appropriate option for this building.
- 2) Replacement siding should match the wood type and finish of the existing siding.
- 3) Bring the stair railings up to code in a manner similar to the upgraded railings at VAPA.
- 4) Repair or replace the greenhouse; the glass in the structure should be appropriate for the Vermont climate.

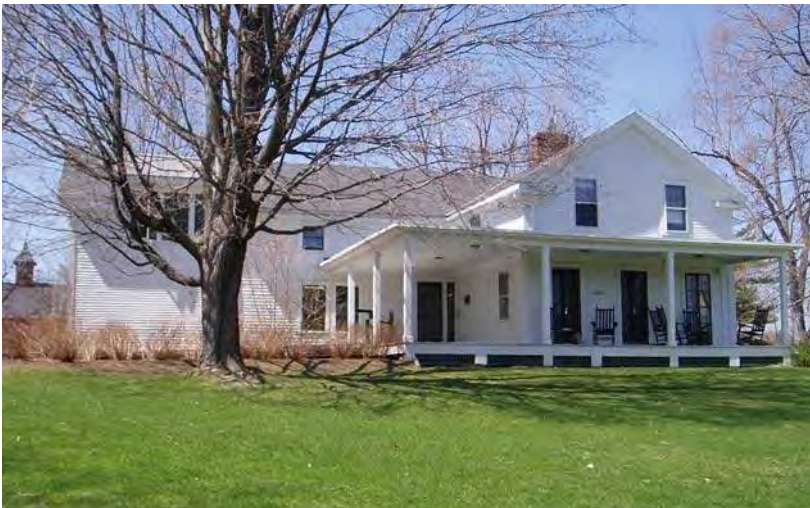
Front elevation looking west.

- 1) Foundation repairs: new mortar should match the historic mortar color, texture, strength and profile.
- 2) Windows: The existing window types are appropriate to the age of the building and its appendages. Retaining the existing windows and repairing as necessary is the best preservation option when windows are a historic feature. When a window has gone beyond its useful life and can no longer be reasonably repaired, new single-glazed wood windows to match the historic muntin patterns and profiles are recommended.

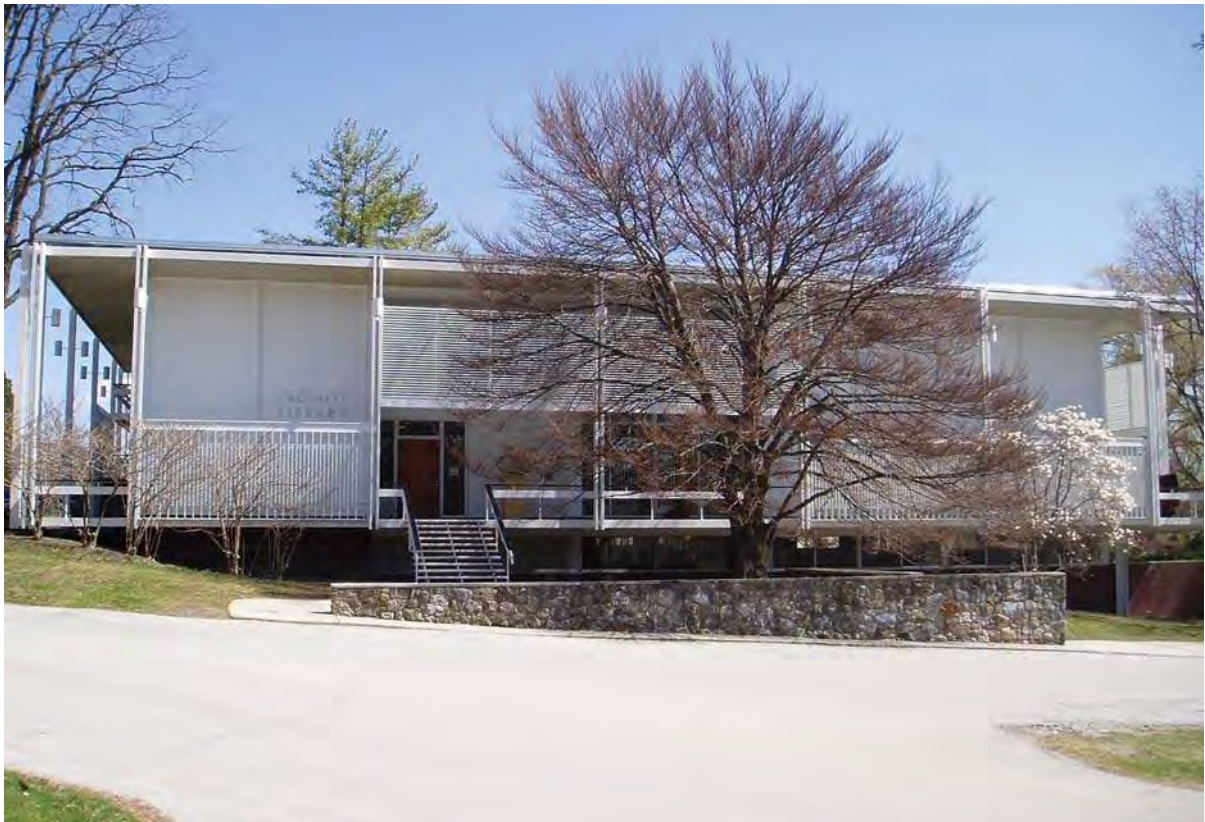
Front (west) elevation.

- 1) Retain the distinctive exterior and interior features of this highly significant building, repairing elements where necessary to match the historic material and dimensions, replacing with new in-kind material only when the element has gone beyond the point of reasonable repair.
- 2) A new addition should not dominate the visual prominence of this building on campus, particularly from the front elevation. Attention to the site, size and materials of a new addition to avoid adverse impacts is paramount. An addition off the rear, possibly joined to the historic library by a small, low connecting structure is recommended as an appropriate option to consider.

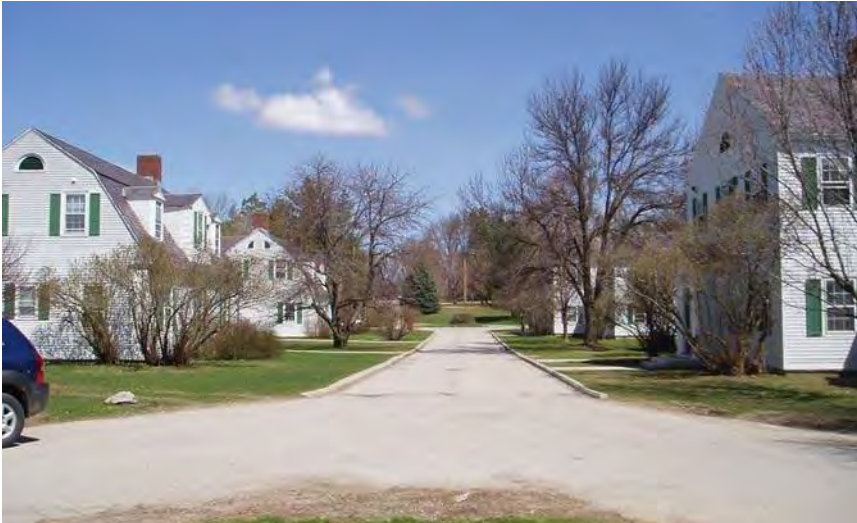
View to north, left to right: McCullough, Leigh, Booth, Kilpatrick (#s 19, 20, 15, 16)

- 1) Siding: remove aluminum siding and restore clapboards, replacing to match where necessary
- 2) Windows: Retain existing wood windows, which are a significant component of the character of the houses; replace storms as necessary.
- 3) Roofing: Continue to maintain the distinctive slate roofing.
- 4) Floorplan: interior modifications will not have an adverse impact if the primary spaces including entry halls, stairs, and living rooms are preserved.
- 5) Upgrade kitchens and bathrooms as necessary to accommodate current needs.

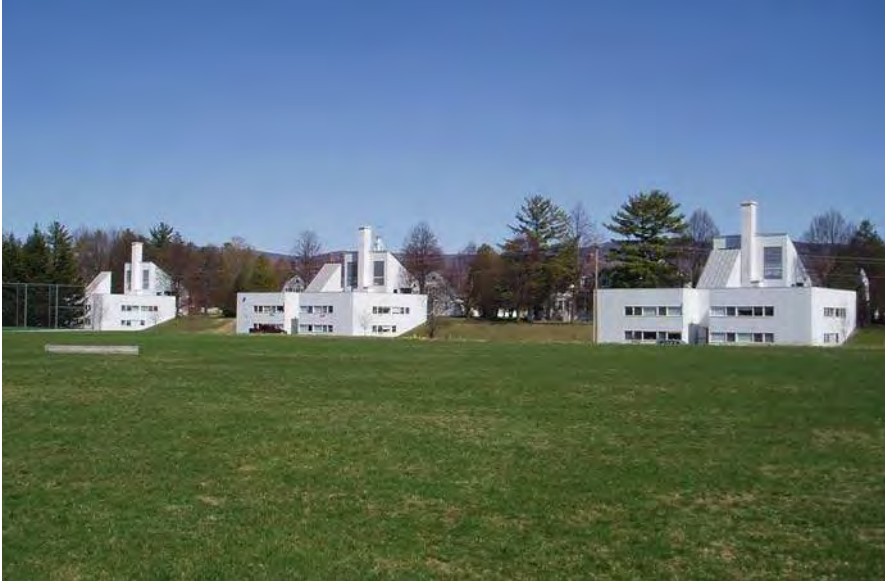
View looking northeast of rear elevations.

- 1) Siding: remove the aluminum siding and restore the vertical cedar siding underneath.
- 2) Windows: replace the awning windows with casements that can provide better ventilation.
- 3) Floor plan: Alterations that provide better living accommodations for students or faculty will not substantially alter the integrity of these buildings, as the exteriors retain the most significance.

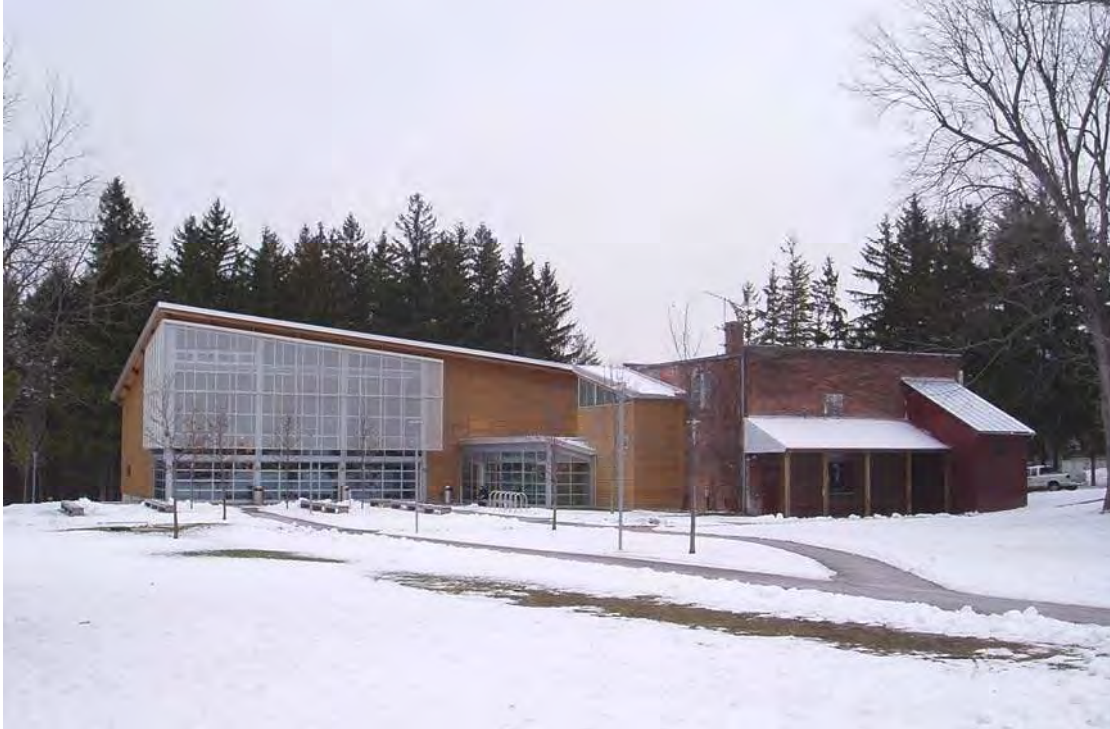
View looking west of new Student Center on left, former brick garage on right.

- 1) Due to the recent rehabilitation of the Brick Garage and the new construction of the Student Center, no recommendations are necessary.

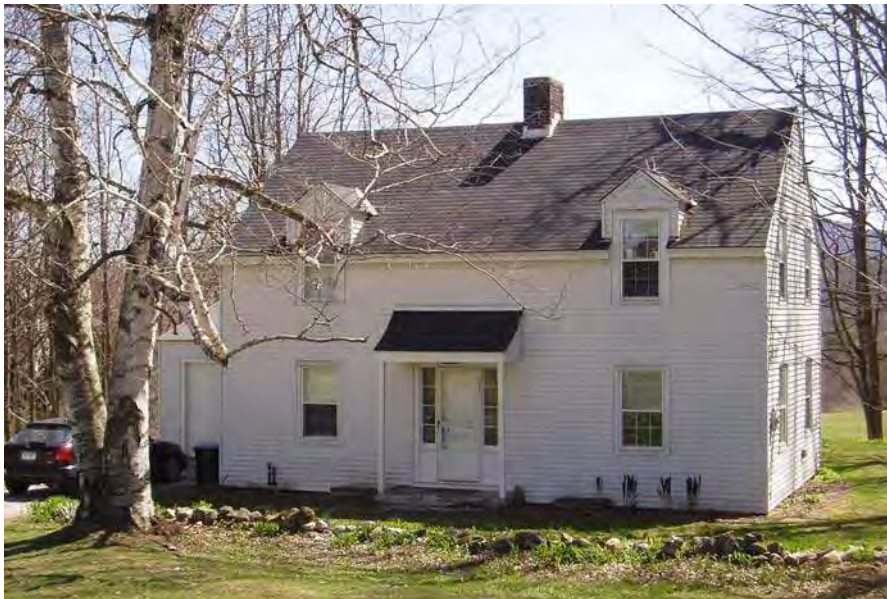
Gray, Faculty Row #1, Historic District Map #34.

- 1) Siding: Remove the aluminum siding and repair clapboards underneath or replace where siding is missing or deteriorated.
- 2) Interior work: Upgrade kitchens and bathrooms as determined necessary.
- 3) Landscaping: Improve the landscaping around the buildings.

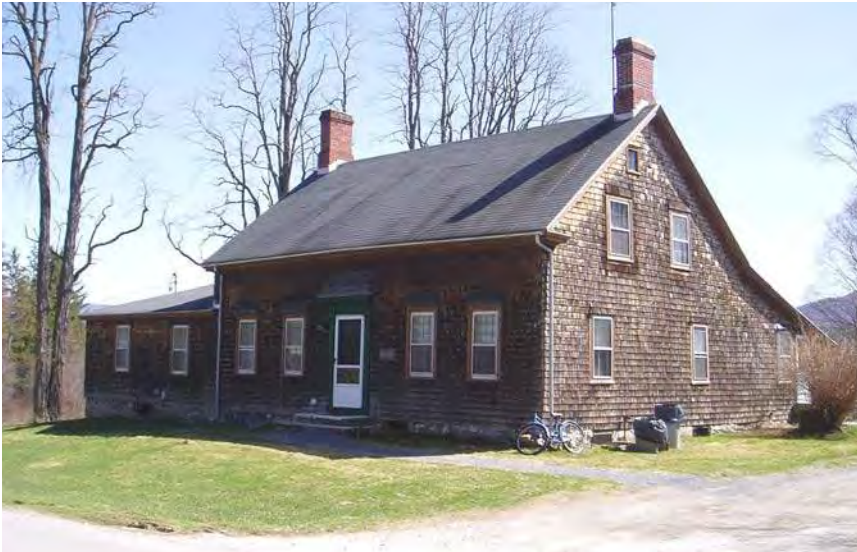
Front and north elevations showing saltbox form.

- 1) Retain the significant features of the dwelling as noted above, paying particular attention to exterior details, and the interior features of the rear unit, which are the more noteworthy of the two apartments.
- 2) Replace wood shingles as necessary.
- 3) Adapting the building for use as the Early Childhood Center as proposed in the 2004 Campus Plan is appropriate with the condition that the rear apartment floorplan and features are preserved as much as reasonably possible. In addition, because more space will be required to house the ECC than exists in Shingle Cottage, a new building or addition to this one will be needed. Designs for a new addition or new building nearby should allow the historic cottage to dominate and not be overwhelmed by a larger addition.

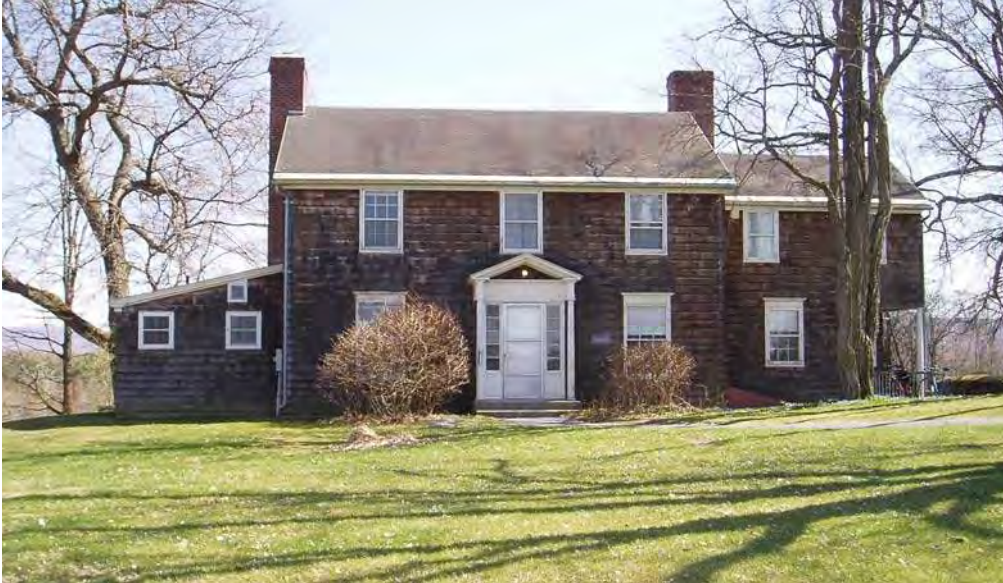
North elevation.

- 2) Replace the wood shingle siding.
- 3) Upgrade the kitchens and bathrooms.
- 4) Uses and rehabilitation treatments that will not negatively impact the domestic character of the house are recommended.

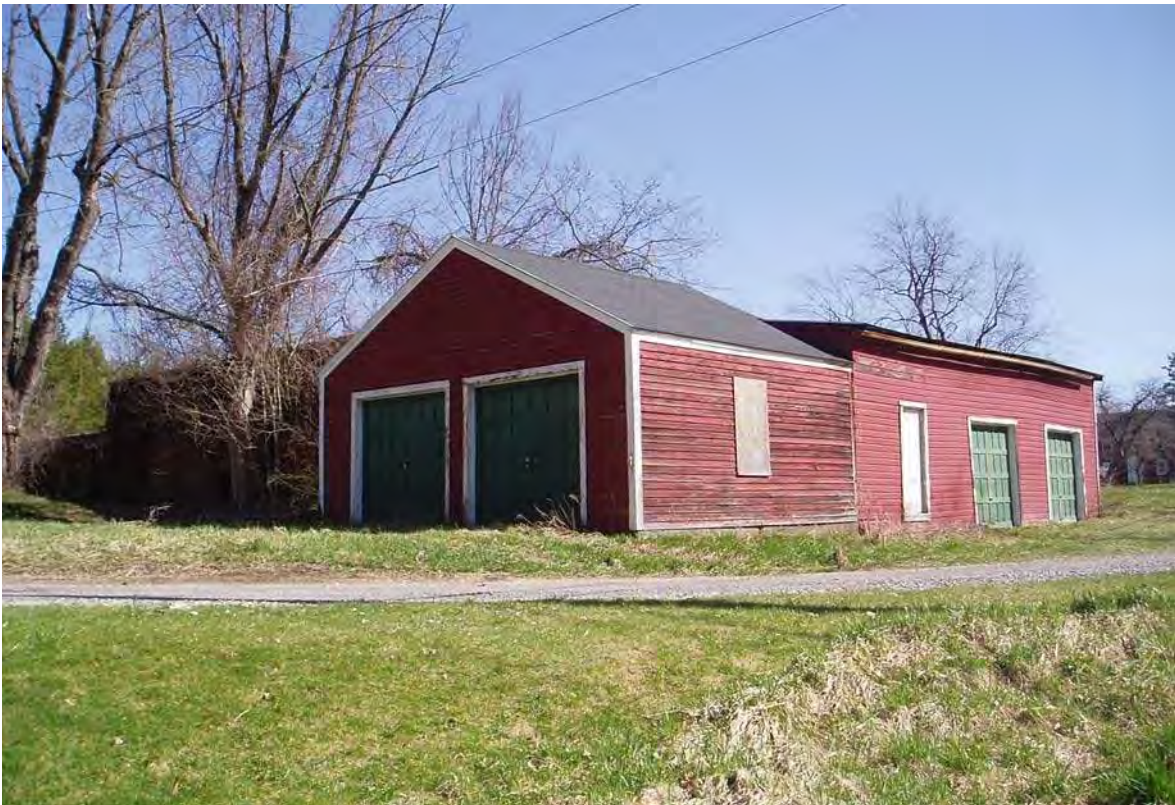
View looking southeast; walled garden at rear on left.

- 1) Investigate the condition of the siding, framing and roofing and repair as necessary with in-kind materials.
- 2) If the building is determined in very poor condition, and due to its small size, the limited potential for uses other than storage, and the cost to rehabilitate it, taking down the structure and using the funds to restore more significant campus buildings could possibly justify demolition as a reasonable treatment option.

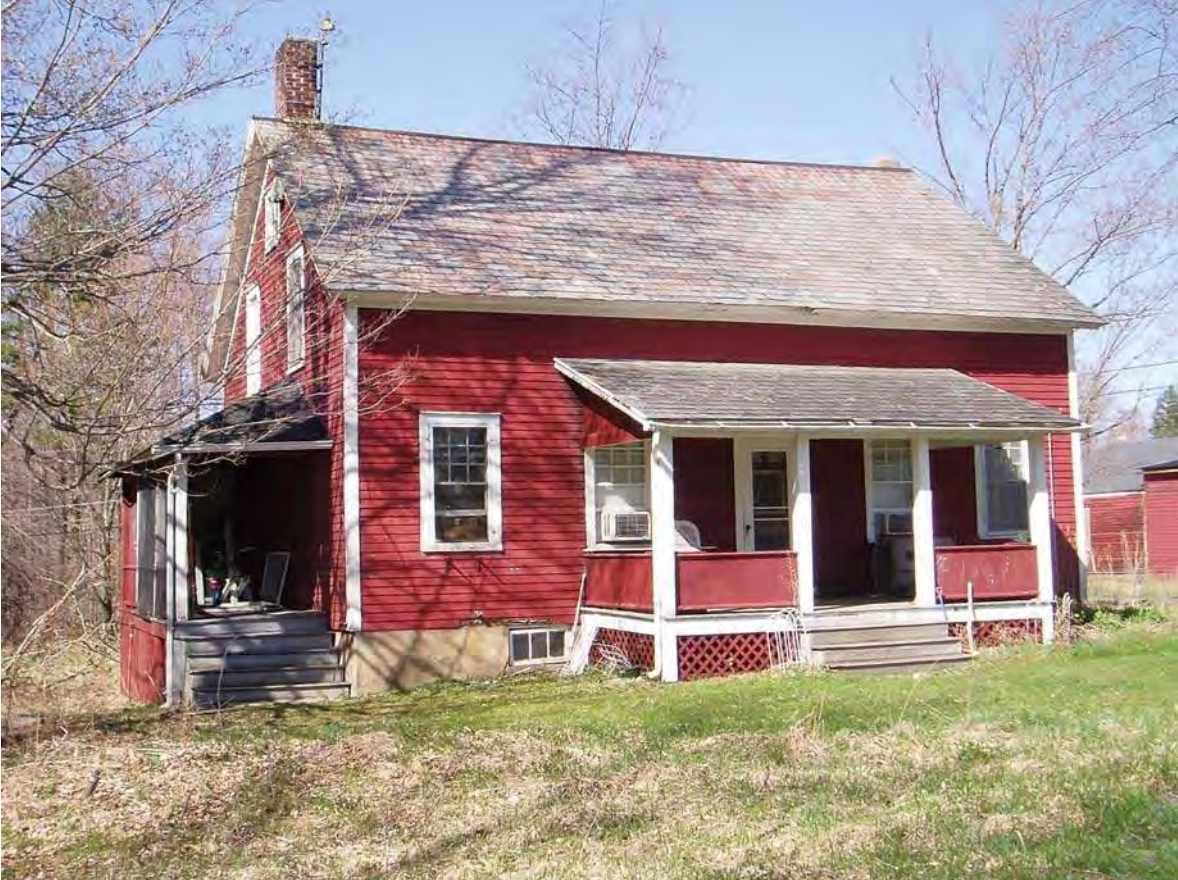
View looking north; walled garden at rear on right.

- 1) Investigate the condition of exterior and interior features. Repair, or replace elements that have gone beyond the point of reasonable repair with in-kind materials matching existing dimensions and profiles.

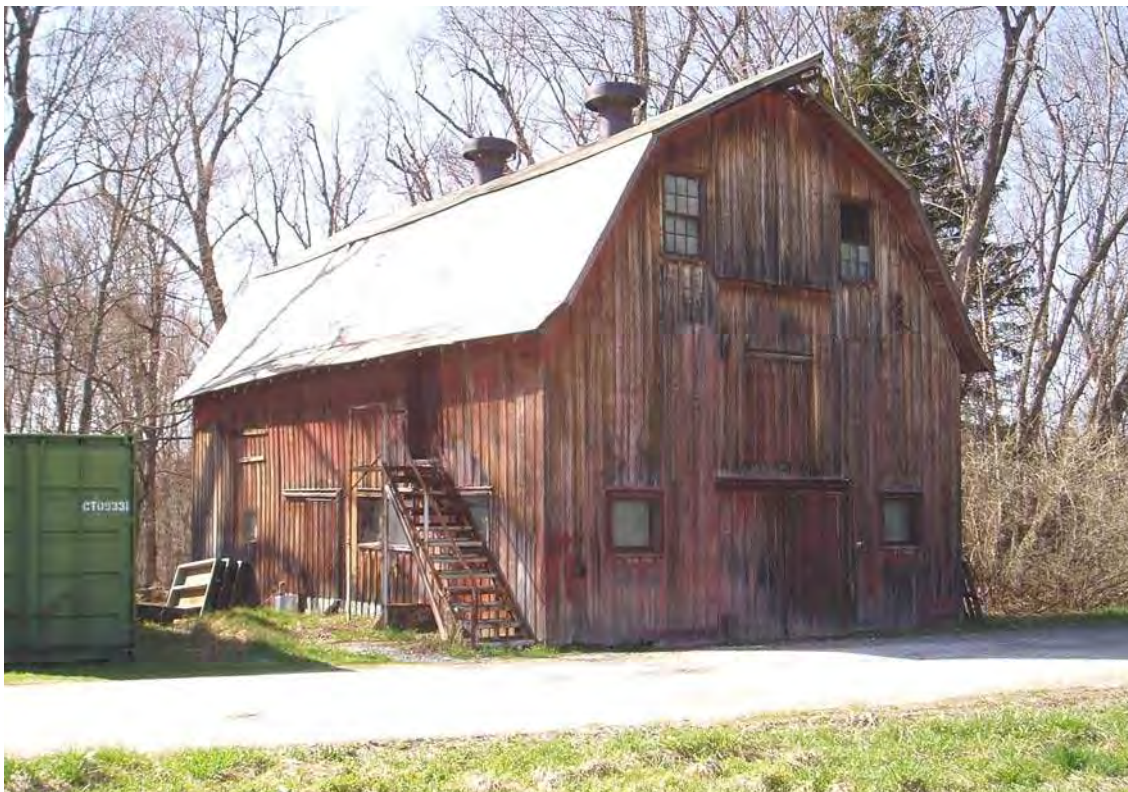
View looking west.

- 1) Investigate the condition of the siding, framing and roofing and repair as necessary with in-kind materials.
- 2) Remove the exterior stairs from the south elevation, and repair interior stairs if they remain or build new stairs to the second floor.

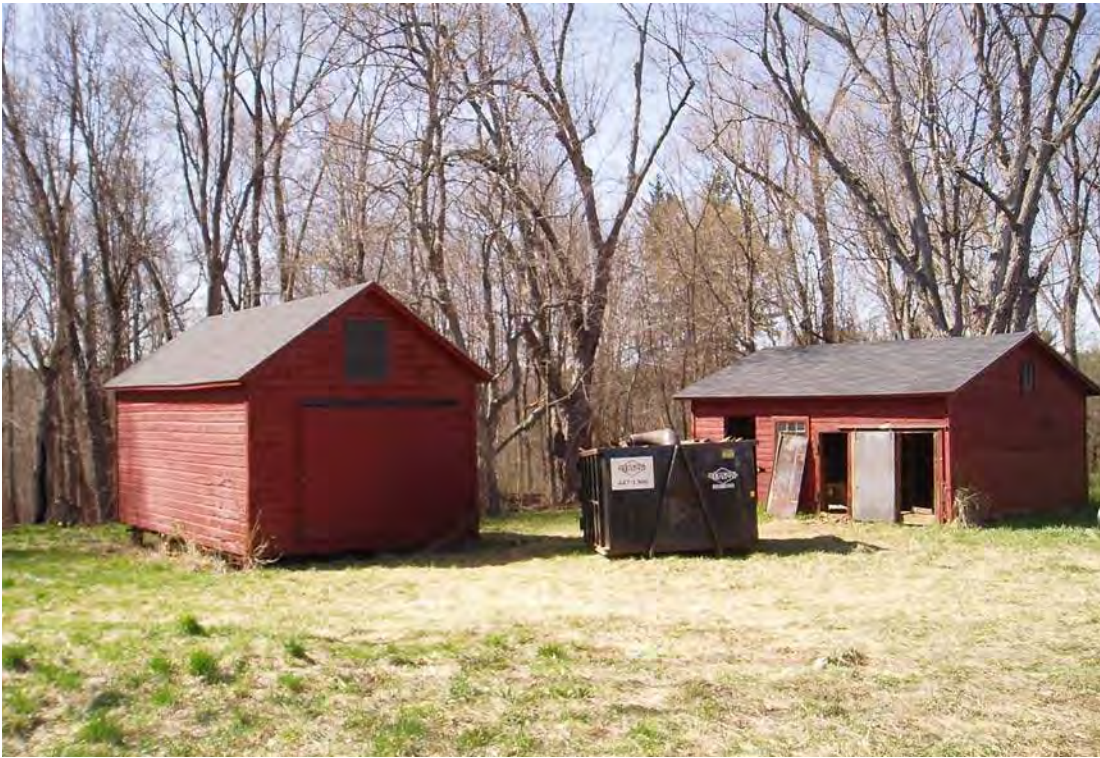
View looking west; Pig House (#50) on right, Corn Crib (#51) on left.

- 1) Analyze the cost to repair the two buildings to make them useful to the College. If a suitable use is found such as storage, and the rehabilitation costs are reasonable continue to use the buildings for storage or other worthy purpose. If no worthy academic use is found, or the cost of rehabilitation is not reasonable considering the value of the buildings to the College, other options are appropriate, such as finding a suitable new owner that can move the buildings off-site to reuse them on a new location. Or, if a new owner can not be found, demolition of the buildings can likely be justified as a last, but least preferred option.
